## Summary of Lower Platte & Elkhorn Rivers

### Initial Ice Report 2/17/2018 through 2/23/2018:

#### Ice Thickness Summary (2/22/2018)

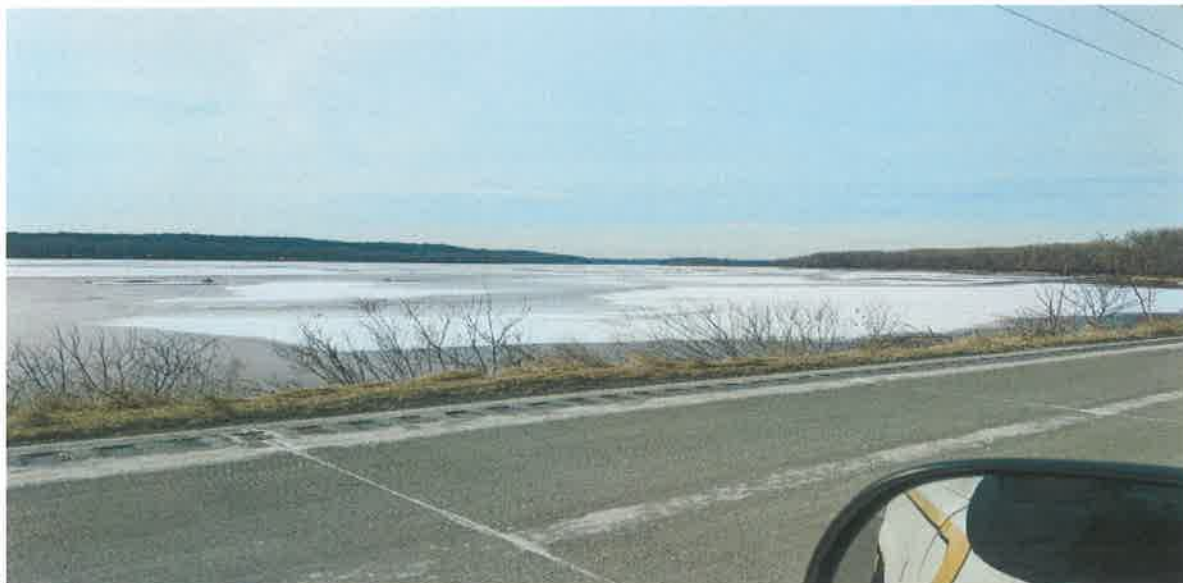
P7 - Sarpy County, on the Platte Hwy 31 at 204 St.

Temperature was 25°F. The average wind speed was 3 mph (E). It was estimated that it was less than 2 feet bank full at this location. The channel remains 10%. It was noted: " (Following Picture by Jesse Eret, Sarpy Co EMA)

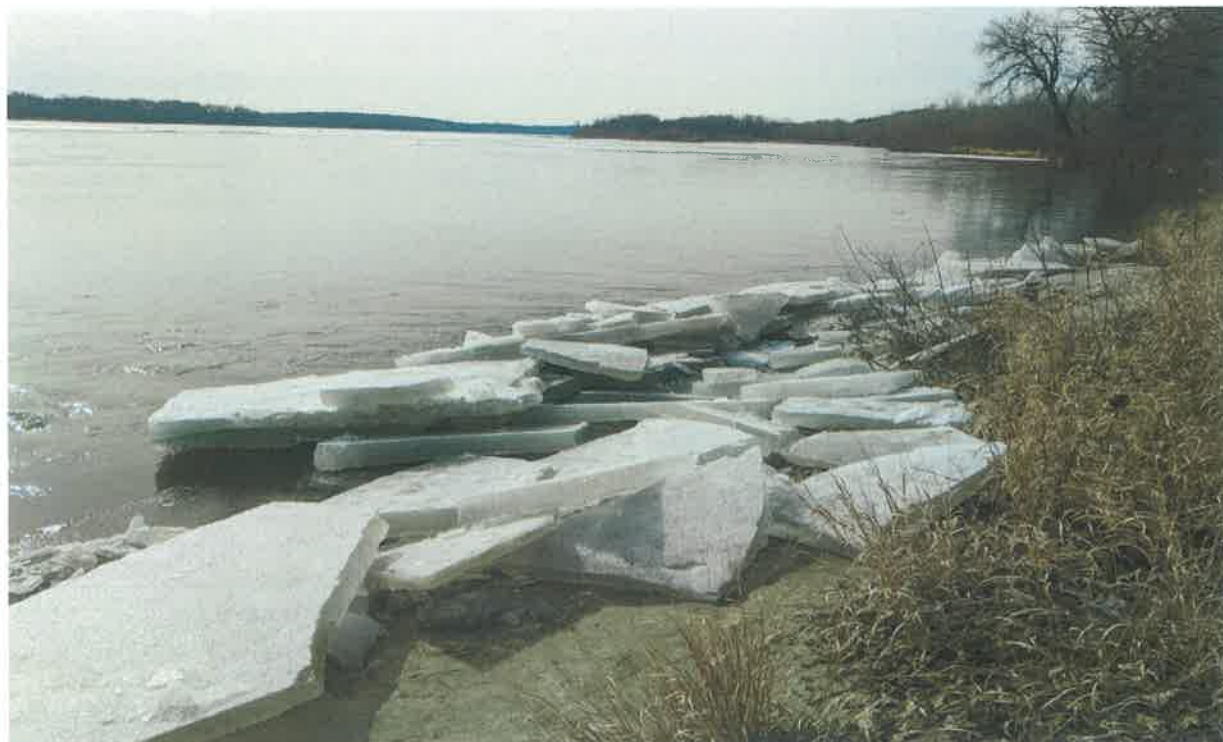
P10 - Sarpy County, on the Platte Hwy 50 & Platte River Bridge

Temperature was 25°F. The average wind speed was 3 mph (E). It was estimated that it was less than 2 feet bank full at this location. The channel remains 65%. It was noted: " (Following Picture by Jesse Eret, Sarpy Co EMA)

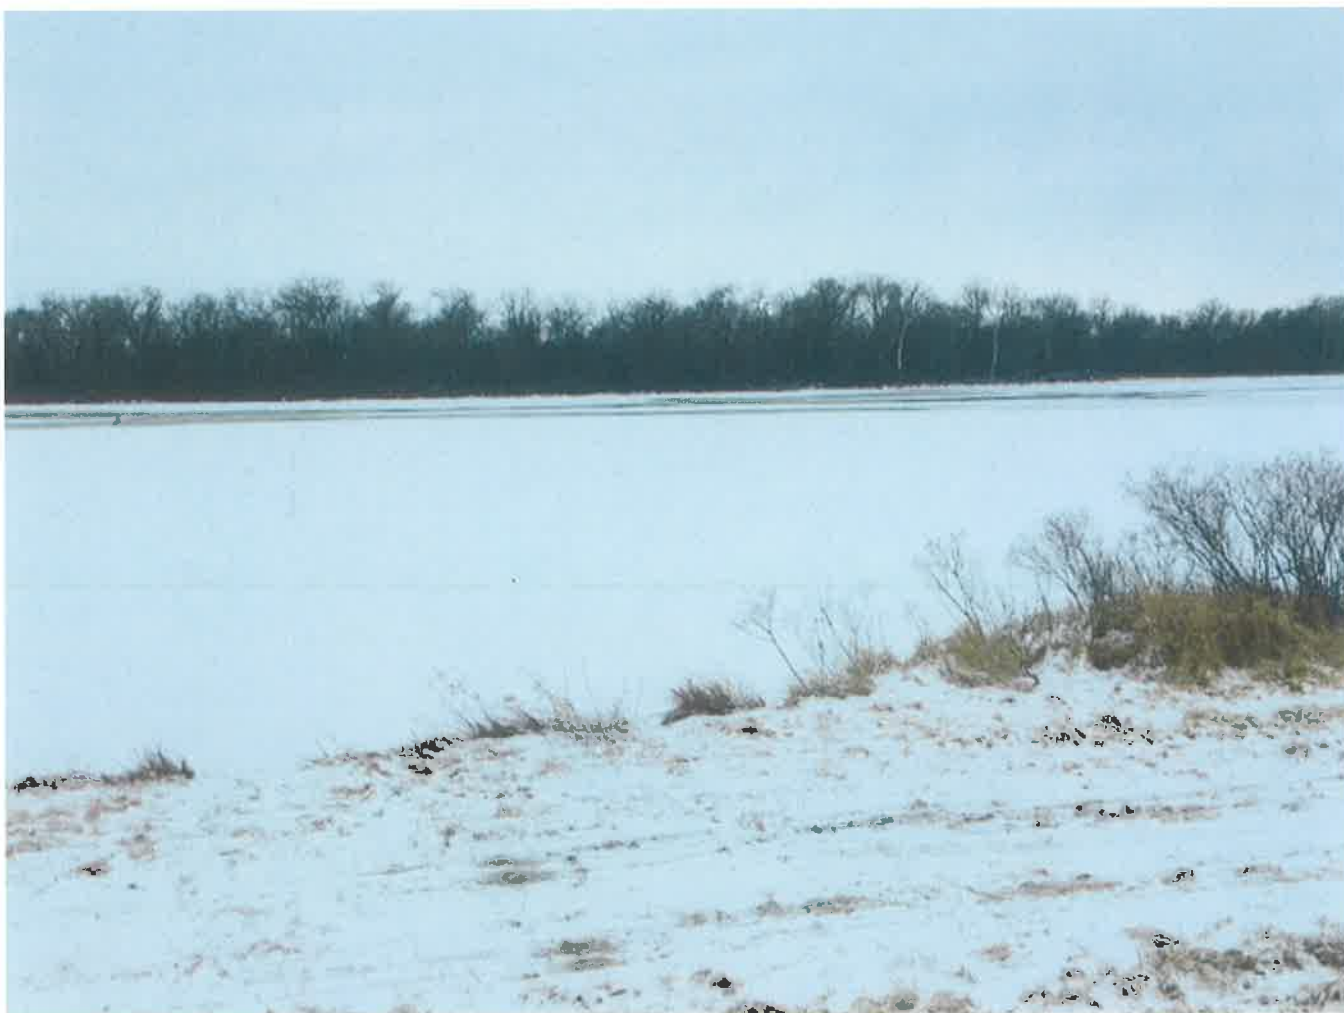
PM7 - Douglas County, on the Platte Union Dike, 1/4 mile west of Hwy 275 & 3.1 miles upstream of Hwy 64

Temperature was 16°F. The average wind speed was 5 mph (NW). It was estimated that it was less than 3 feet bank full at this location. The channel remains NA%. It was noted: "100% ice cover."(Following picture from Martin Cleveland, Papio MO NRD)
