Summary of Lower Platte & Elkhorn Rivers

Initial Ice Report 2/10/2018 through 2/16/2018:

Ice Thickness Summary (2/15/2018)

Memorandum

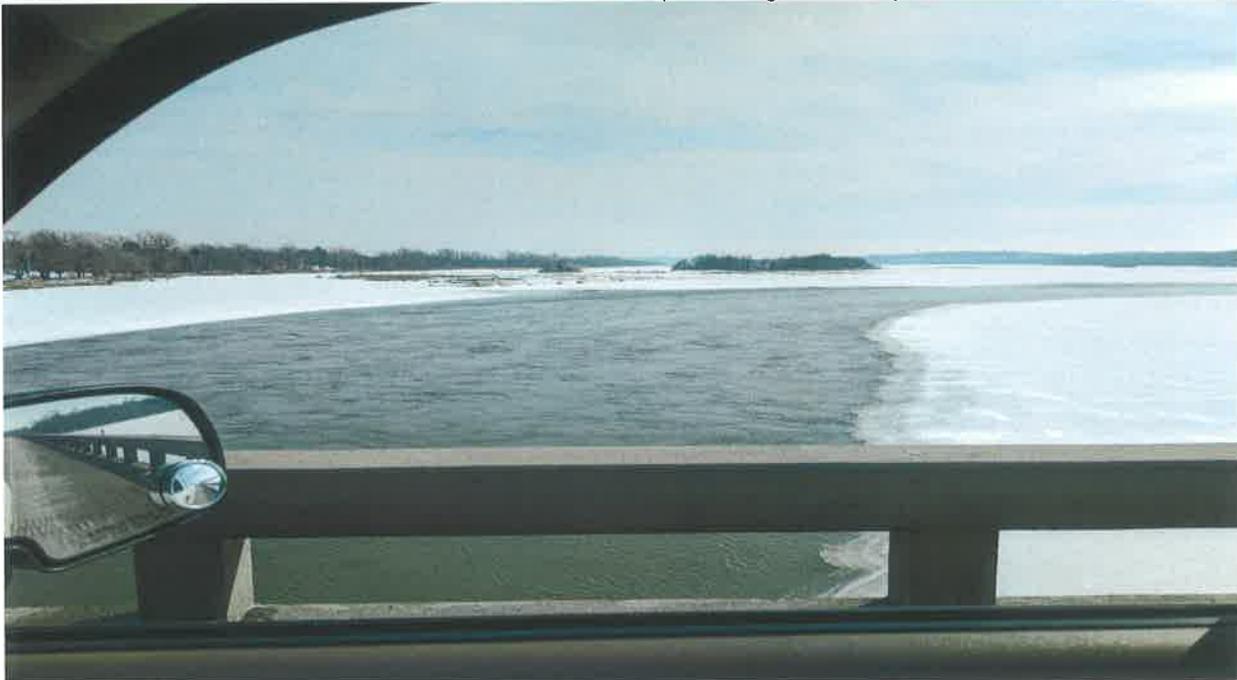
P9 - Sarpy County, on the Platte Hwy 6 & Platte River Bridge (Linoma)

Temperature was 47°F. The average wind speed was 6 mph (S). It was estimated that it was less than 3 feet bank full at this location. The channel remains 20%. It was noted: " (Following Picture by Jesse Eret, Sarpy Co EMA)

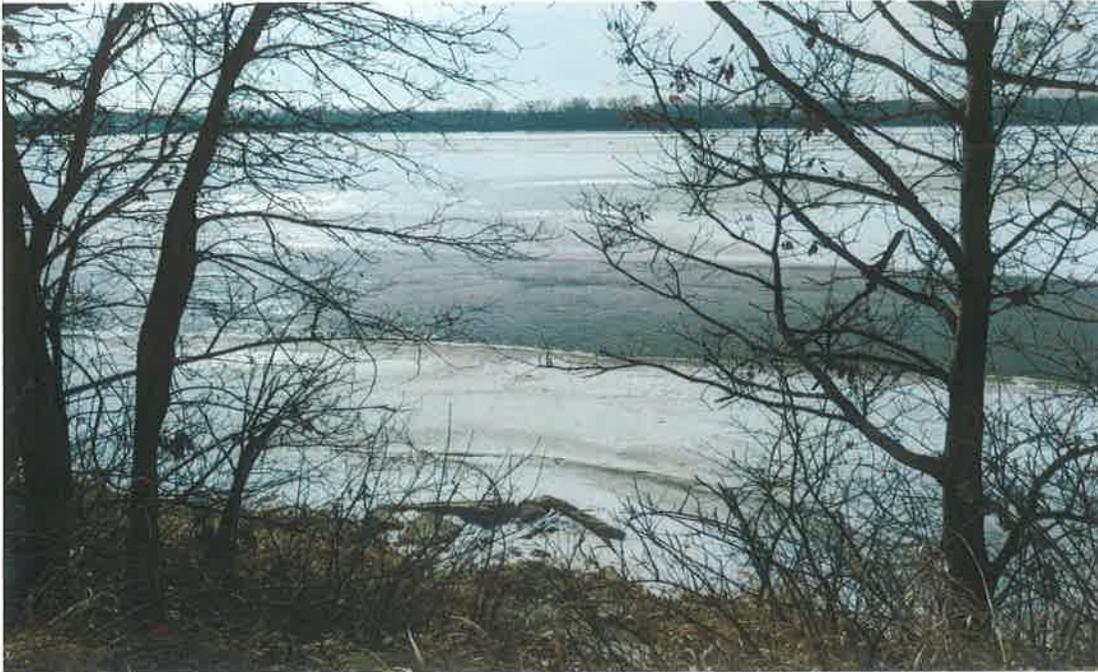
P7 - Sarpy County, on the Platte Hwy 31 at 204 St.

Temperature was 47°F. The average wind speed was 6 mph (S). It was estimated that it was less than 2 feet bank full at this location. The channel remains 5%. It was noted: " (Following Picture by Jesse Eret, Sarpy Co EMA)

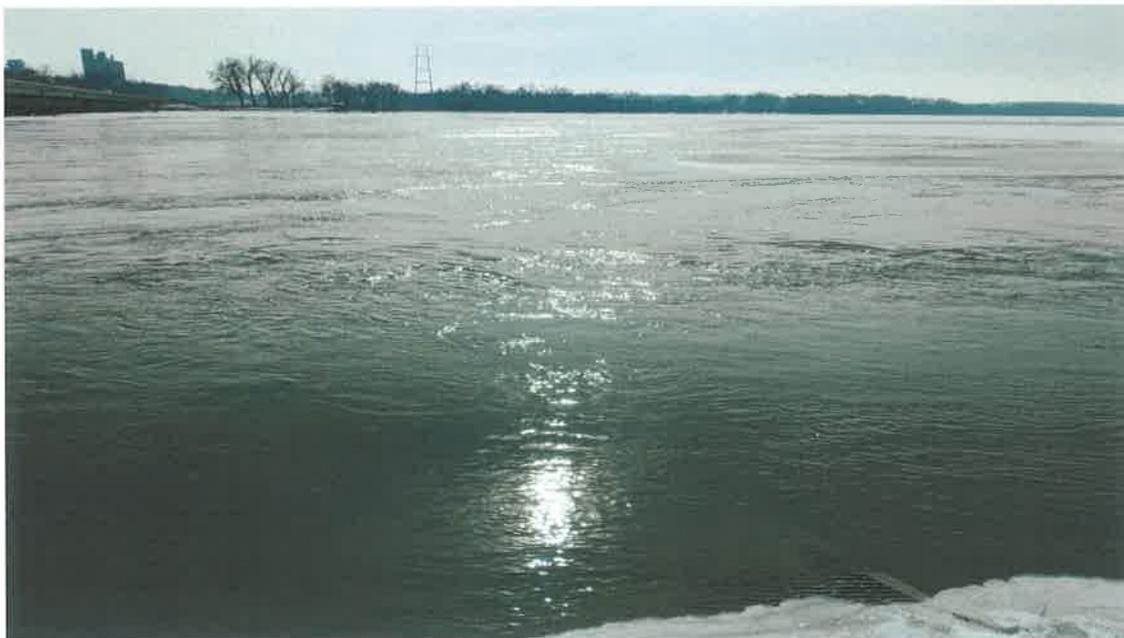
P10 - Sarpy County, on the Platte Hwy 50 & Platte River Bridge

Temperature was 47°F. The average wind speed was 6 mph (S). It was estimated that it was less than 2 feet bank full at this location. The channel remains 95%. It was noted: " (Following Picture by Jesse Eret, Sarpy Co EMA)

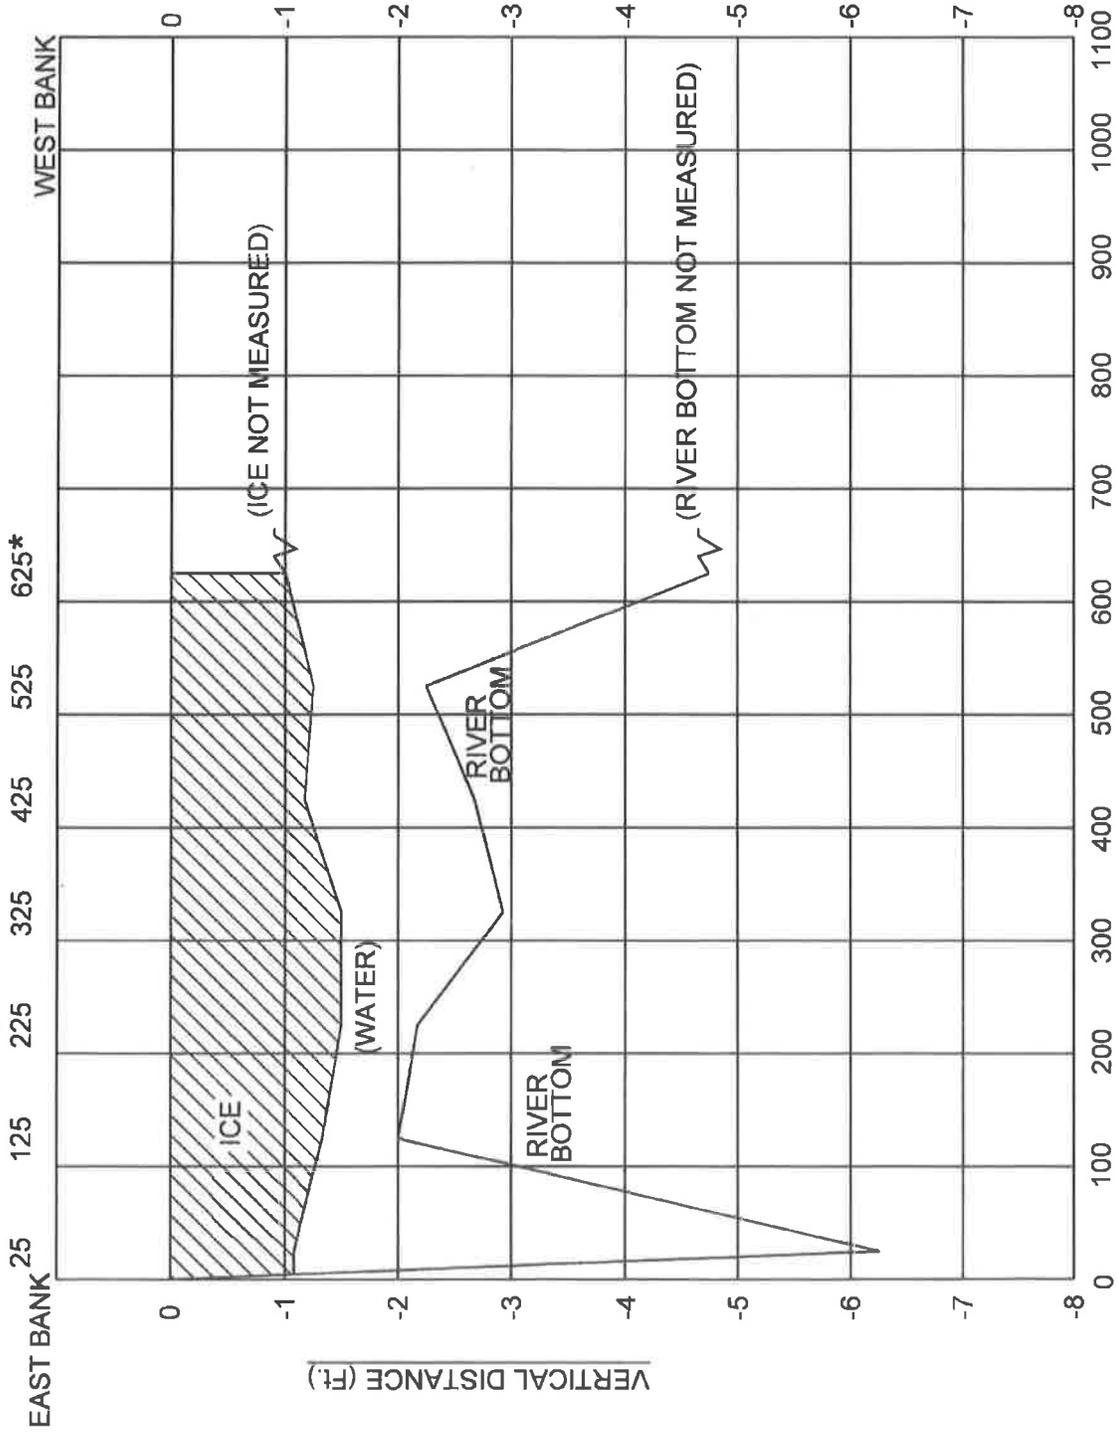
PLATTE RIVER: 1.1 Miles Upstream of Hwy. 64 (STA. 155+00, UNION DIKE)

On February 15, 2018, District staff performed ice thickness measurements on the Platte River. The measurements were taken perpendicular to the river flow, near the dike on the Werner Property, at approximately Station 155+00 (1.1 miles upstream of Highway 64; location is known as 10 jetty site).

Distance From East Bank (Feet)	Ice Thickness (Inches)	Depth From Top Of Ice To River Bed (Inches)
25	13	75
125	16	24
225	18	26
325	18	35
425	14	32
525	15	27
625	12	57

*The entire river has an ice cover, but only the 0 to 625 ft. width of ice from the east bank of the river is considered safe enough to conduct borings. The west bank is approximately 400 feet west of 625 ft. boring.

The average ice thickness is **15.1 inches**.
(Previous 2018 average ice thickness: Jan. 4 – 11.0”; Jan. 18 – 16.0”; Jan. 25 – 15.1”; Feb. 1 – 13.6”; Feb. 8 – 14.3”)

*Hole location is approx. 400' from the west bank.

HORIZONTAL DISTANCE (Ft.)

Looking Downstream
