Summary of Lower Platte & Elkhorn Rivers

Initial Ice Report 2/24/2019 through 3/1/2019:

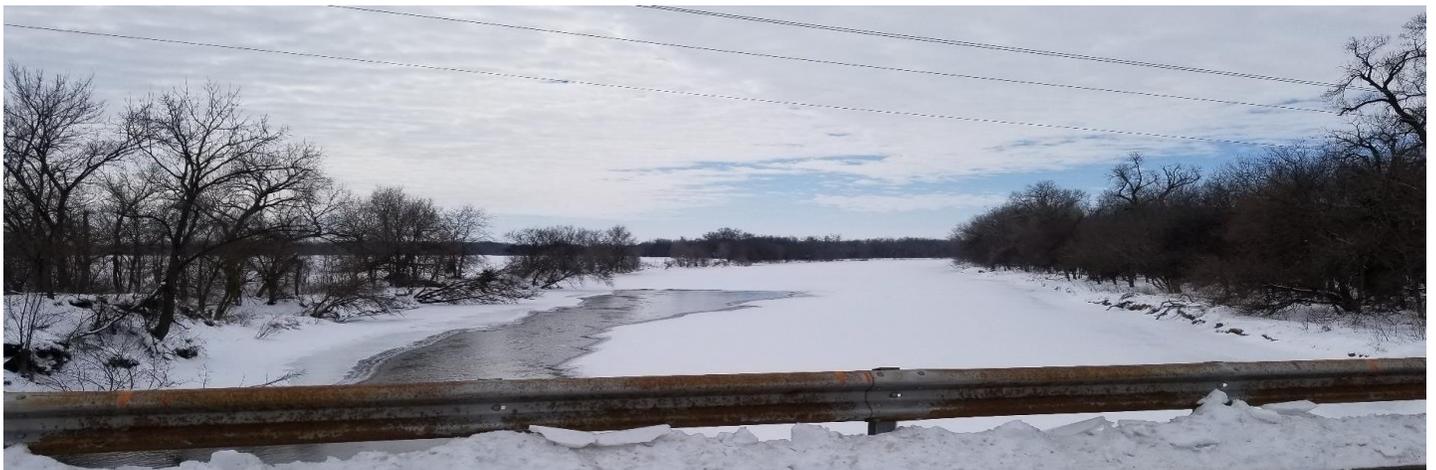
Elkhorn River-Nickerson-Looking North

E4 - Dodge County, on the Elkhorn Hwy 91 near Nickerson

Temperature was N/A°F. The average wind speed was N/A mph (). It was estimated that it was less than N/A feet bank full at this location. The channel remains N/A%. It was noted: "

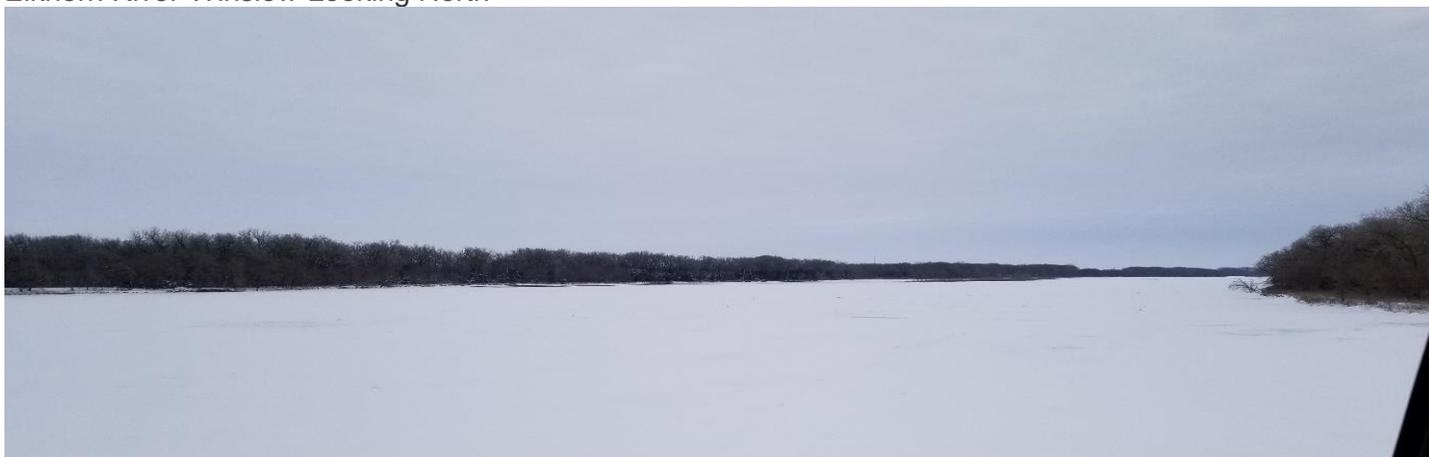
Elkhorn River-Winslow-Looking North

E5 - Dodge County, on the Elkhorn Hwy 77 near Winslow

Temperature was 16°F. The average wind speed was N/A mph (). It was estimated that it was less than N/A feet bank full at this location. The channel remains N/A%. It was noted: “
