Inspection and Maintenance of Your Earthen Dam

Version 1.1, 2017

An informational booklet for dam owners in Nebraska

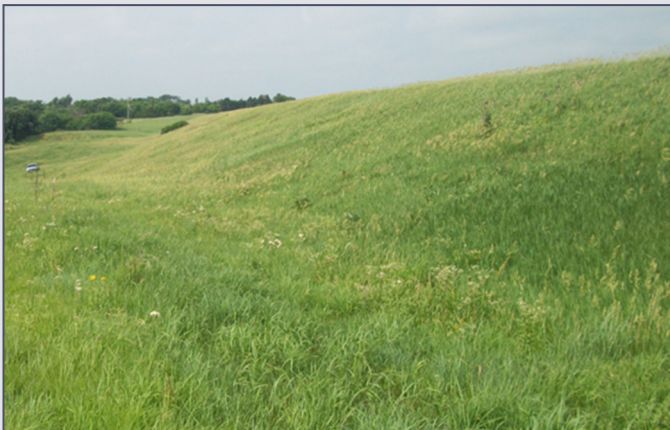
A healthy stand of grass is the best defense against soil erosion.

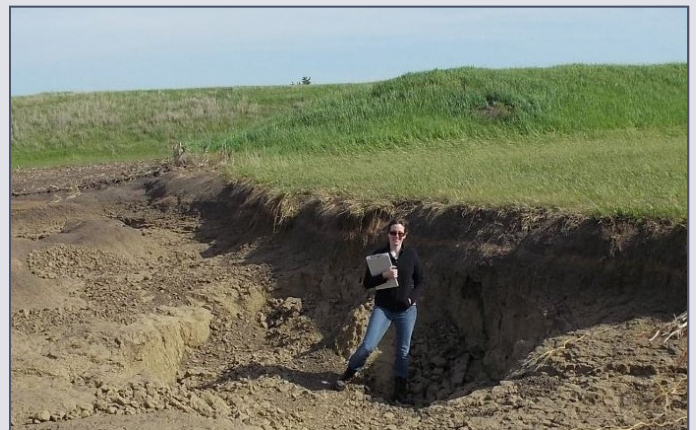
Erosion in auxiliary spillway where grass cover was removed and planted to crops.

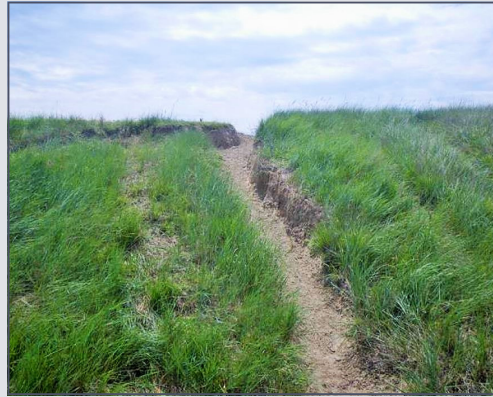
Dam embankment damaged by livestock.

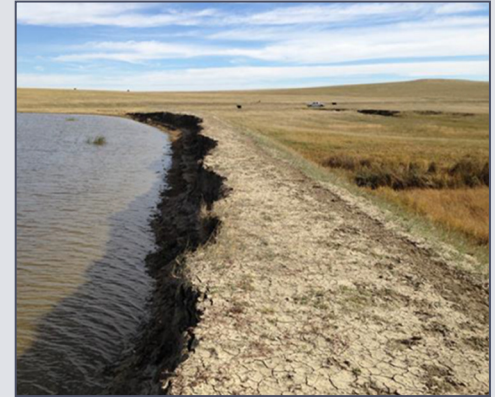
Failure to address erosion issues as they develop leads to costly repairs.

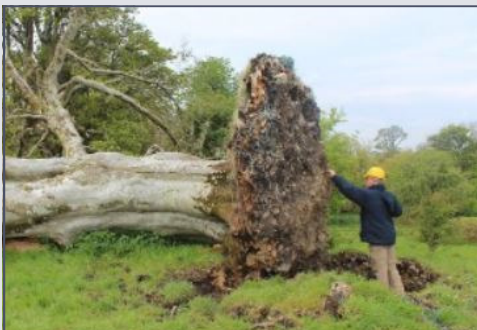
Uprooted trees can remove a significant portion of a dam.

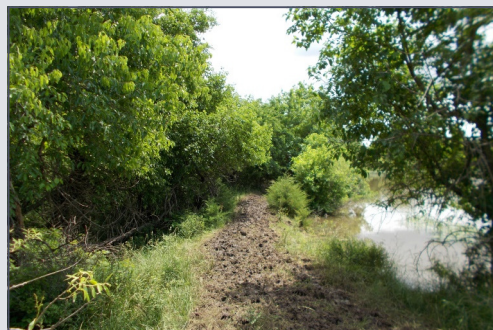
Trees make inspecting the dam difficult and provide attractive habitat for burrowing animals.

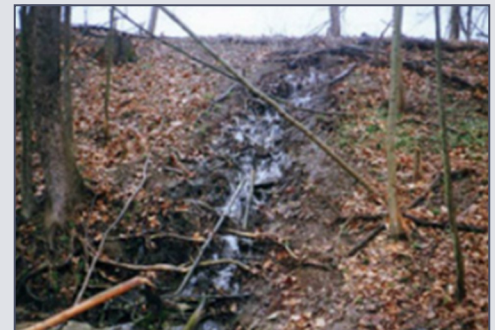
Seepage through dam damaged by tree roots. Trees should not be allowed to grow on dams. (Photo: ASDSO)

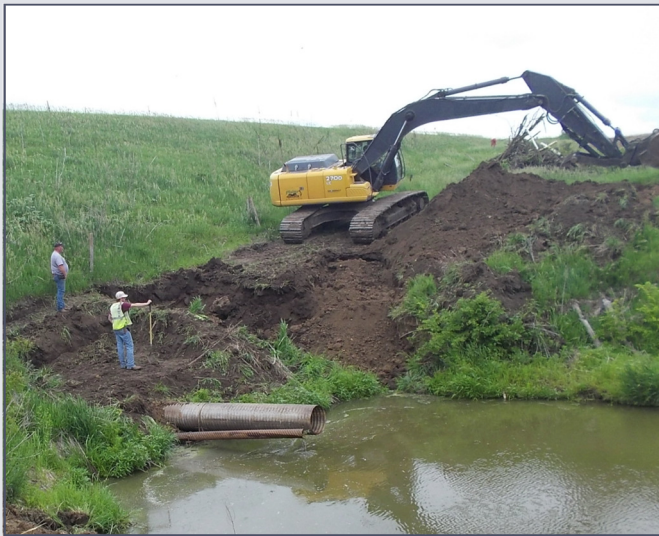
To repair damage, large rodent burrows may need to be excavated and backfilled with compacted soil.

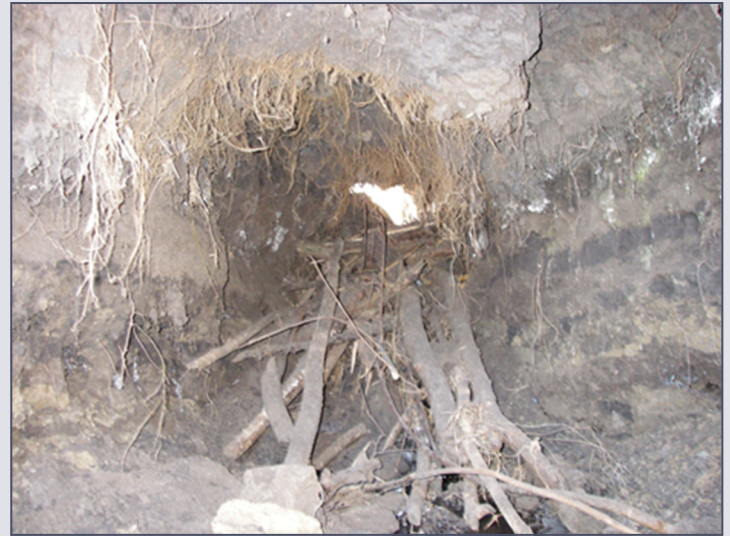
Looking inside a rodent hole that extended from upstream to downstream, entirely through a dam (Note daylight in center of photo).

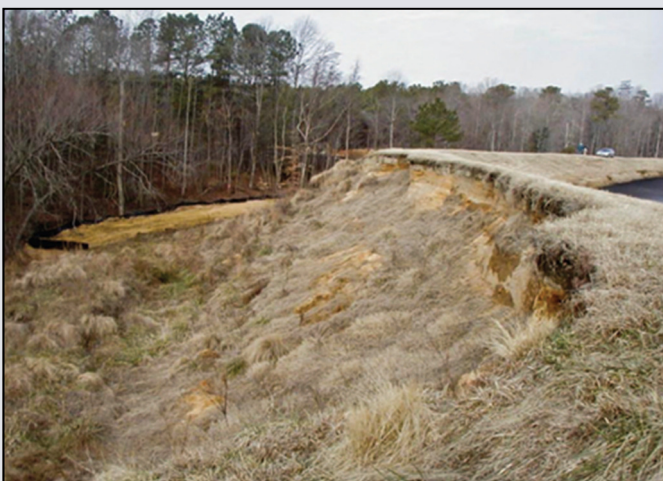
Large slide extending into the crest of a dam. Slides are typically caused by unstable steep slopes and saturated soil conditions following heavy rainfall. Slides can also be caused by rapid draining of the reservoir. (Photo Source: USDA)

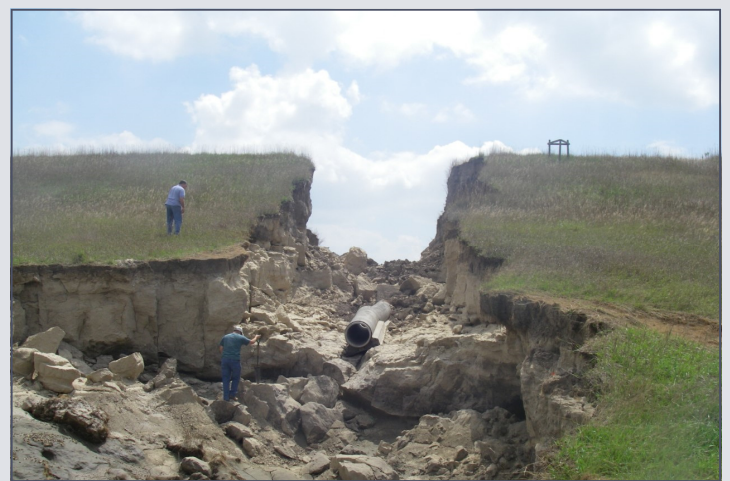
A transverse crack is believed to be the cause of this dam failure in Hitchcock County. Poorly compacted soil in the dam or in the foundation is the most common cause of transverse cracking.

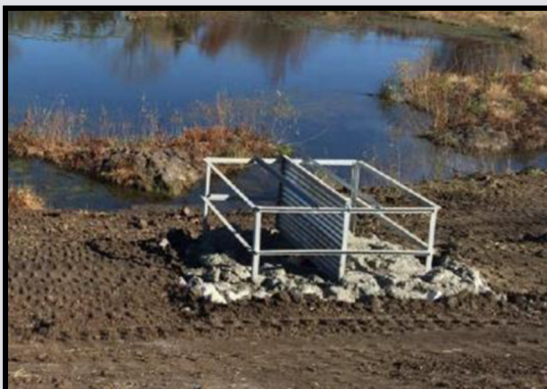
A properly designed trash rack prevents debris from entering a spillway that are too large to freely pass through, while at the same time, facilitating the passage of smaller trash. Trash racks are also important to prevent children and livestock from falling into spillways.

- The openings of a trash rack should be half the diameter of the spillway outlet pipe.
- Trash racks should be sturdy, constructed of metal, and capable of withstanding the weight of several large logs.
- Install a metal trash rack that has been approved for use in Nebraska. Visit <http://dnr.nebraska.gov/dam/examples-of-approved-trash-racks> for more information.

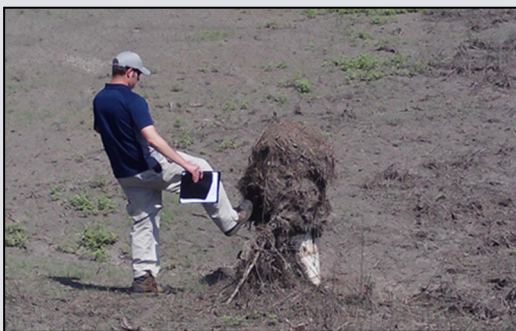
Spillway inlets must be kept free of obstructions. Trash racks will become plugged if the openings of the trash rack are too small to allow small debris, such as leaves, grass and twigs, to pass. The openings in a trash rack should be about half the diameter of the spillway outlet pipe. A fence to prevent fish passage may be added around an inlet as long as it is kept at least 5 feet from the inlet on all sides, it does not extend more than 2 feet above the normal water level, and it is not placed over the top of the inlet.

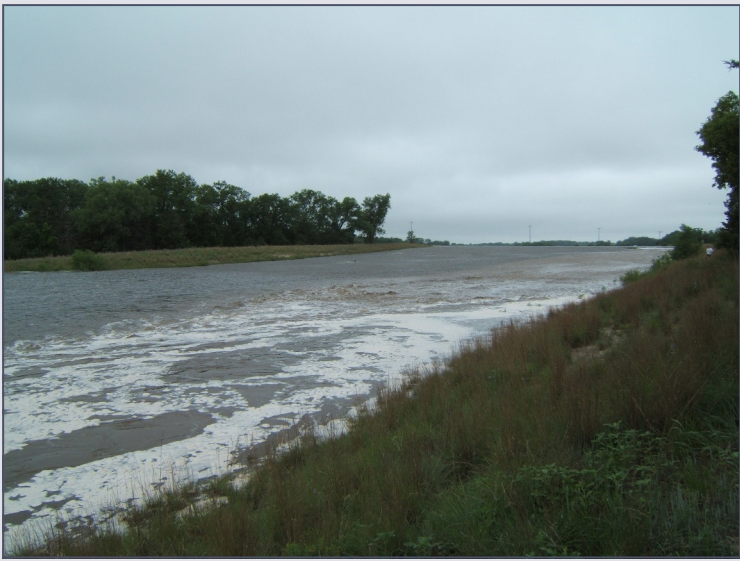
Auxiliary spillway flowing at a dam in Wheeler County. Spillways should be kept free of obstructions such as trees, posts, fence lines, and equipment that will catch debris and cause turbulent flow.

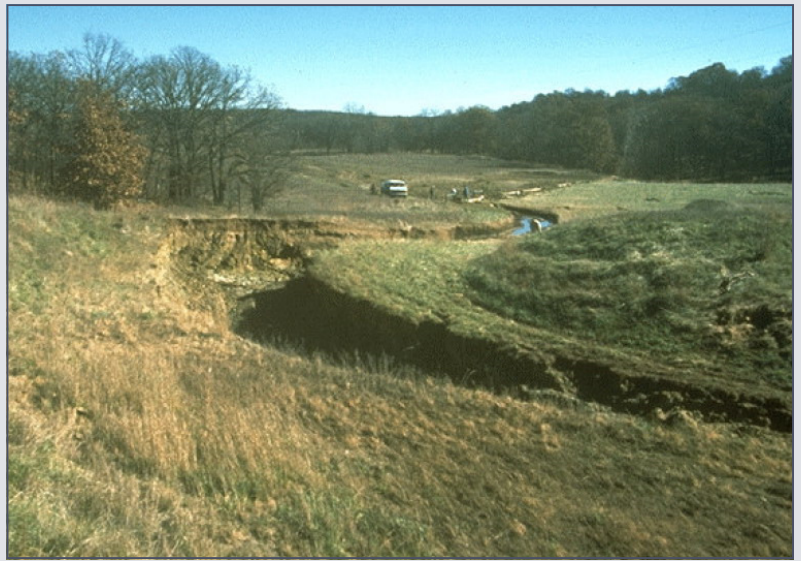
Vehicle paths in the auxiliary spillway led to failure of this dam in Kansas. Vehicle ruts and cattle trails in earthen spillways must be repaired and reseeded to prevent erosion. (Photo source: Darrel Temple)

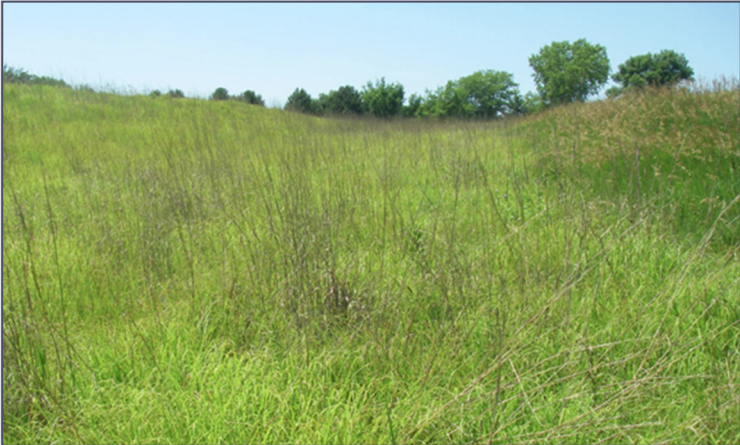
A well-maintained vegetated earthen spillway has a healthy, dense grass cover (no crops, vehicle ruts, or cattle paths) and smooth slopes (no abrupt transitions). Earthen spillways also must be kept free of obstructions that can collect debris and cause flow turbulence such as trees, fence lines, hay bales, and farm equipment.

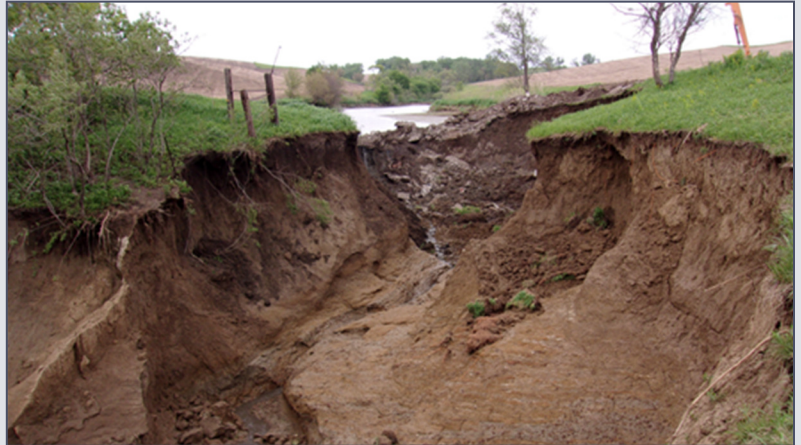
Failure of dam in Dixon County due to erosion in the vegetated earthen auxiliary spillway. A healthy, uniform grass cover is critical. One imperfection in a vegetated spillway, such as a small patch of dead grass, can be the starting point for erosion. Once erosion begins, the eroded area can quickly grow in size and breach the dam.

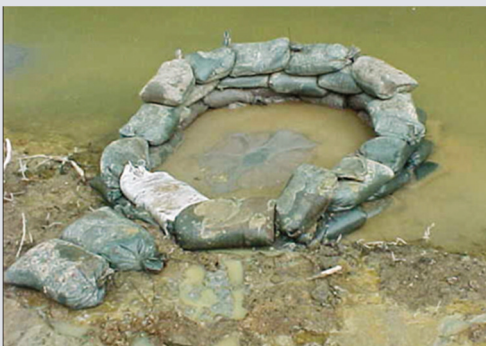
Sandbags surrounding a boil on the downstream side of a dam to pond water and create back pressure. (Photo source: USDA)

- Inspect seepage areas frequently, especially when the reservoir level is high.
- Consider having a qualified engineer design corrective measures to control seepage and boils.
- If seepage is cloudy or muddy, or if soil particles are flowing out of a boil; lower the reservoir level and notify NeDNR (402-471-2363). Build a temporary dike with sand bags around the seepage area/boil to pond water and stop the movement of soil particles.

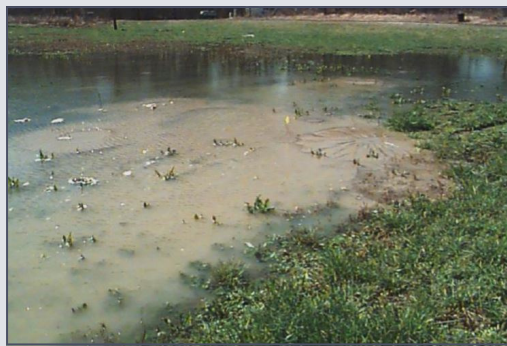
Severe example of a boil and seepage with significant cloudy flow. Cloudy flow is a sign that erosion is occurring inside a dam (Photo source: FEMA)

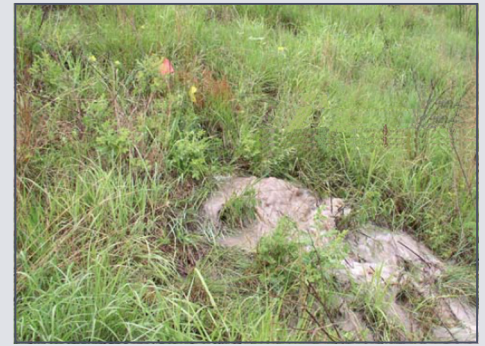
Cloudy seepage emerging from the downstream slope of dam in Frontier County, an indication that internal dam erosion was occurring. (Photo source: NRCS)

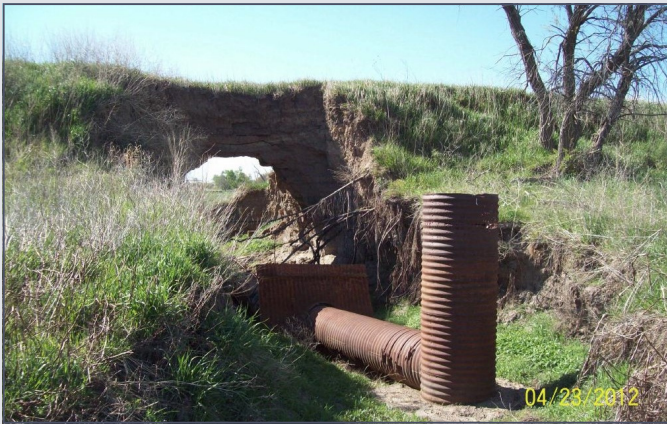
Corrosion of the corrugated metal principal spillway pipe led to this dam failure in Adams County.

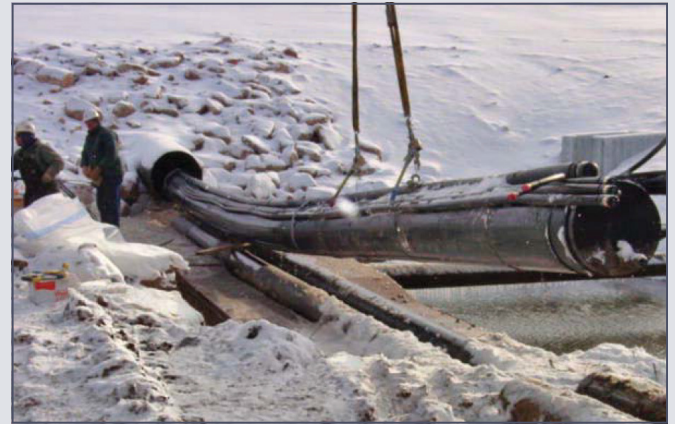
Rusty corrugated metal pipes can be sliplined with pressure-tight, solid-wall, HDPE pipe. Grout is injected into the space between the old and new pipes. (Photo source: FEMA)

- Small cracks in concrete structures should be sealed with a quality polyurethane caulk.
- Maintain protective galvanization, paints and coatings on metal structures and reinforcing steel.
- Apply concrete sealers or topcoats to protect slightly weathered concrete.
- Slipline corroded corrugated metal pipes with pressure-tight plastic pipe that is grouted in place or line the pipe with cast-in-place pipe.
- Severely deteriorated outlet conduits and structures should be evaluated by a qualified engineer to determine the best course of action.

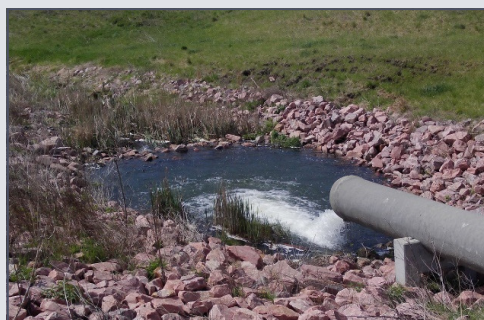
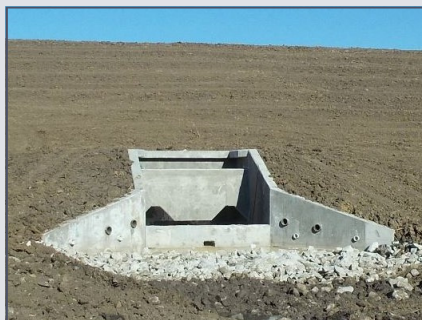
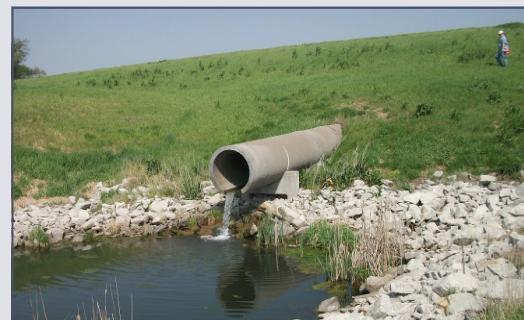
A well-designed plunge pool (left, right) or stilling basin (center) can prevent erosion at the outlet of spillway pipes.

✓31. Concrete or Riprap Deterioration in Plunge Pool/Stilling Basin

- Natural weathering will cause deterioration of poor quality concrete and riprap.
- Deterioration of plunge pool or stilling basin can lead to erosion and costly repairs.
- A poorly designed plunge pool or stilling basin will fail during high flows and be ineffective in preventing erosion.

- See section 27 on page 15 for maintenance of concrete structures.
- Supplement deteriorated and missing riprap with additional rock riprap.
- Severely deteriorated plunge pools and stilling basins should be evaluated by a qualified engineer to determine the best course of action.

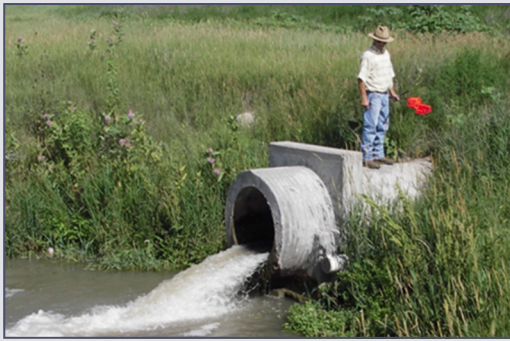
Spillway outlets must be free flowing to discharge water as designed.

- Beaver dams, accumulated sediment, and other obstructions placed in outlet channels can back water up into spillway outlets, reducing their capacity.
- Reduced discharge capacity will cause the reservoir to rise and possibly overtop the dam. Prolonged overtopping can cause dam failure.
- Standing water in corrugated metal pipes accelerates corrosion.

- Remove beaver dams, sediment, and other obstructions in outlet channels so water does not back up into spillway pipes.
- Use extreme caution when attempting to remove accumulated debris during periods of high flow.
- **Keep your distance when removing debris so that you do not become trapped in flowing water when the flow increases. The blockage may break loose at any time.**

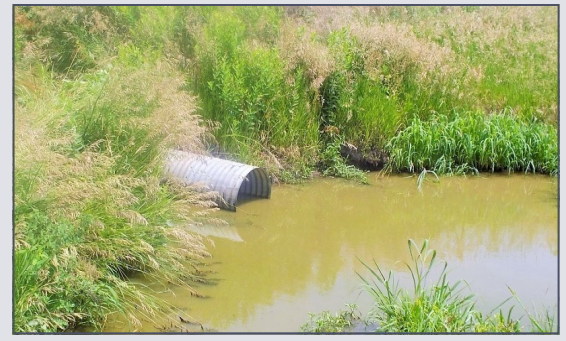
Standing water in outlet pipes accelerates corrosion of metal pipes and reduces spillway capacity.
