## Summary of Lower Platte & Elkhorn Rivers

### Initial Ice Report 1/14/2017 through 1/20/2017:

#### Summary (1/20/2017)

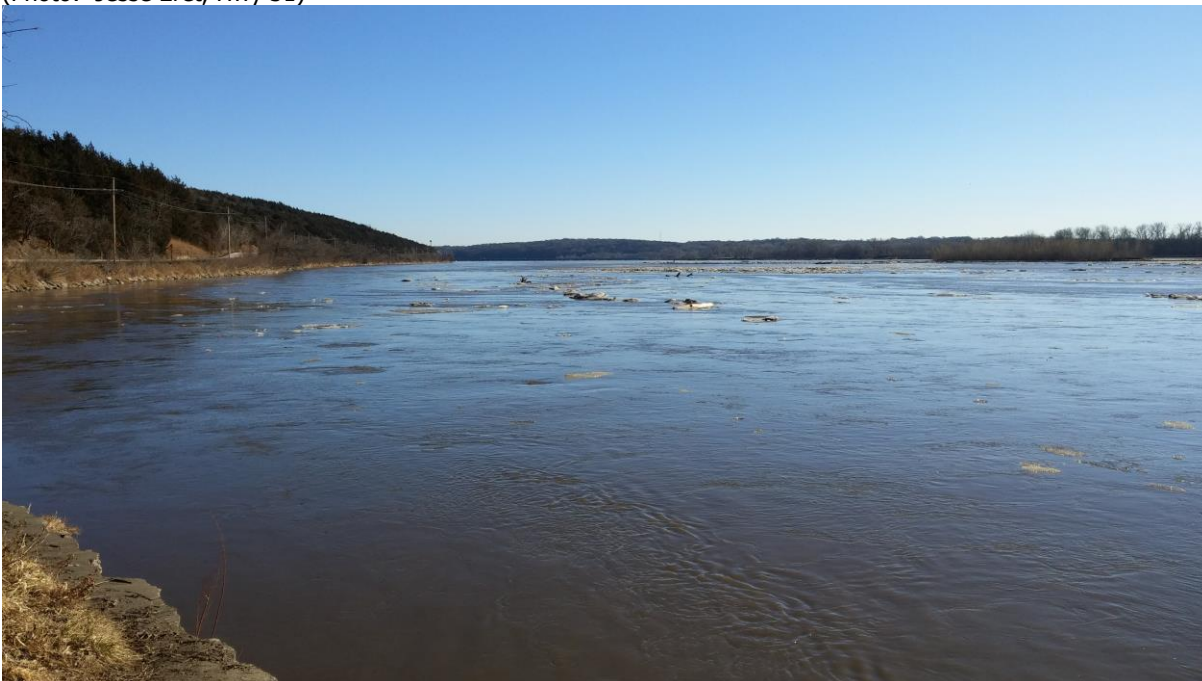
(Photo: Jesse Eret, Hwy 31)

Temperature was 53°F. The average wind speed was 10 mph (SW). It was estimated that it was less than 4.77 feet bank full at this location. The channel remains 100%. It was noted: "The channel is 100% open with some fragmented ice sheets moving downstream from an upstream breakup."
